BEFORE THE FEDERAL EMERGENCY MANAGEMENT AGENCY
FLOOD INSURANCE RATE MAP APPEAL RESOLUTION
CONGAREE RIVER, RICHLAND AND LEXINGTON COUNTIES, S.C.

REPLY OF CITIZEN APPELLANTS

SUBMITTED JULY 20, 2001

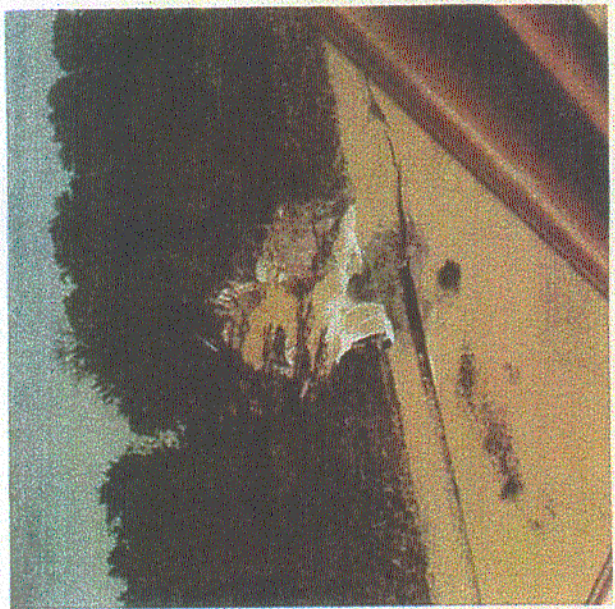
North looking W

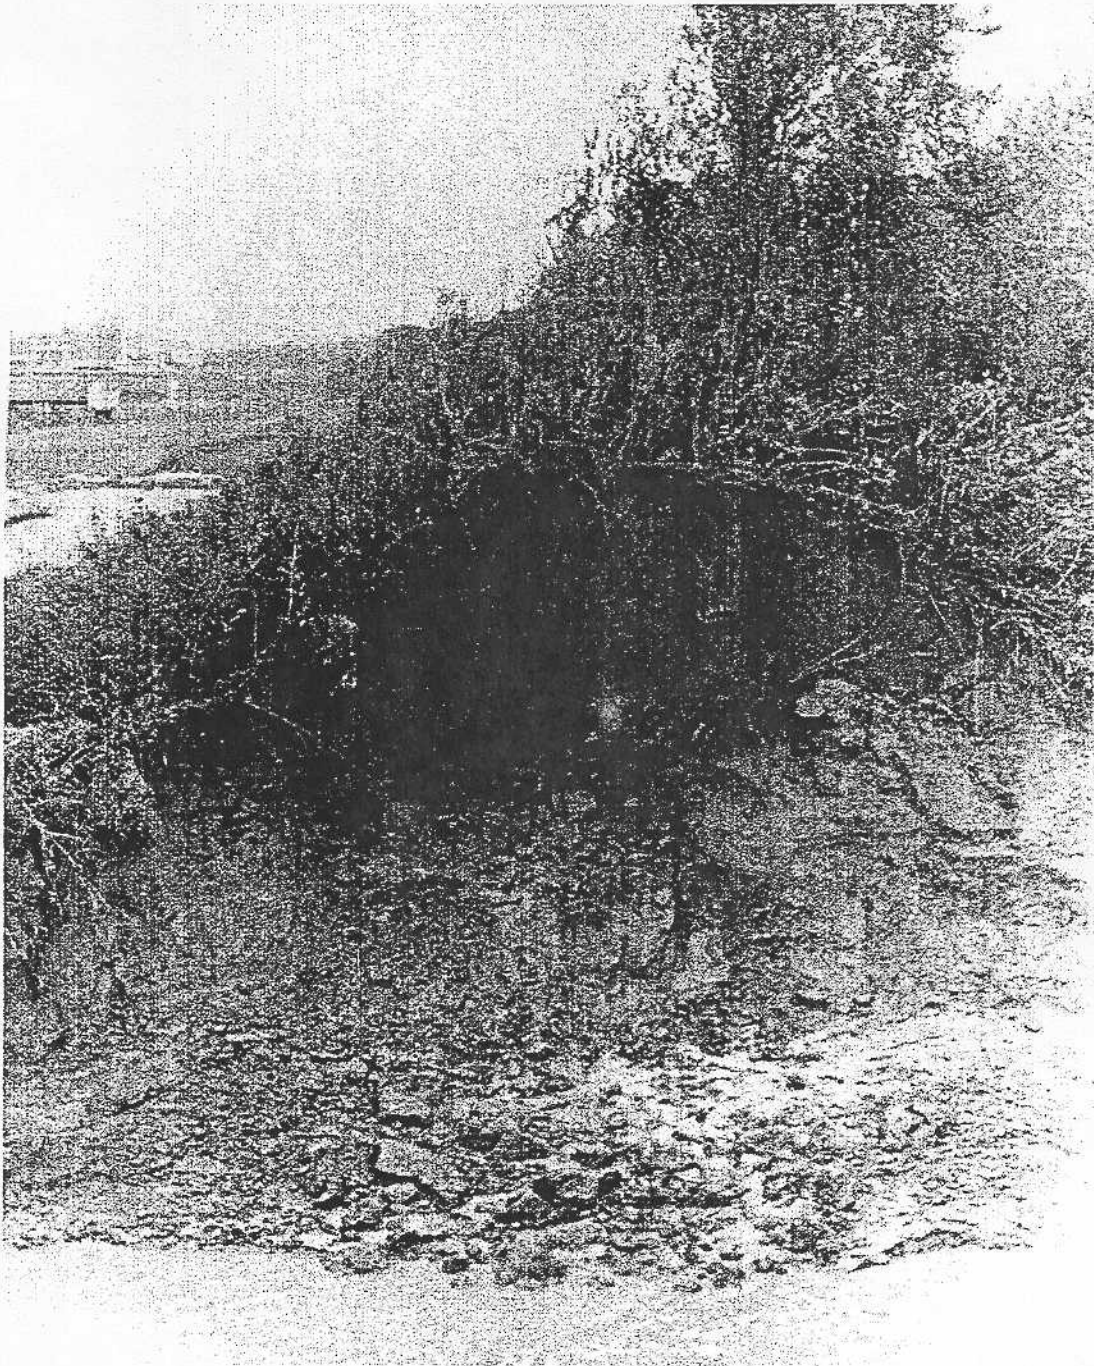
1976 Ring 1 Breach (North) looking South

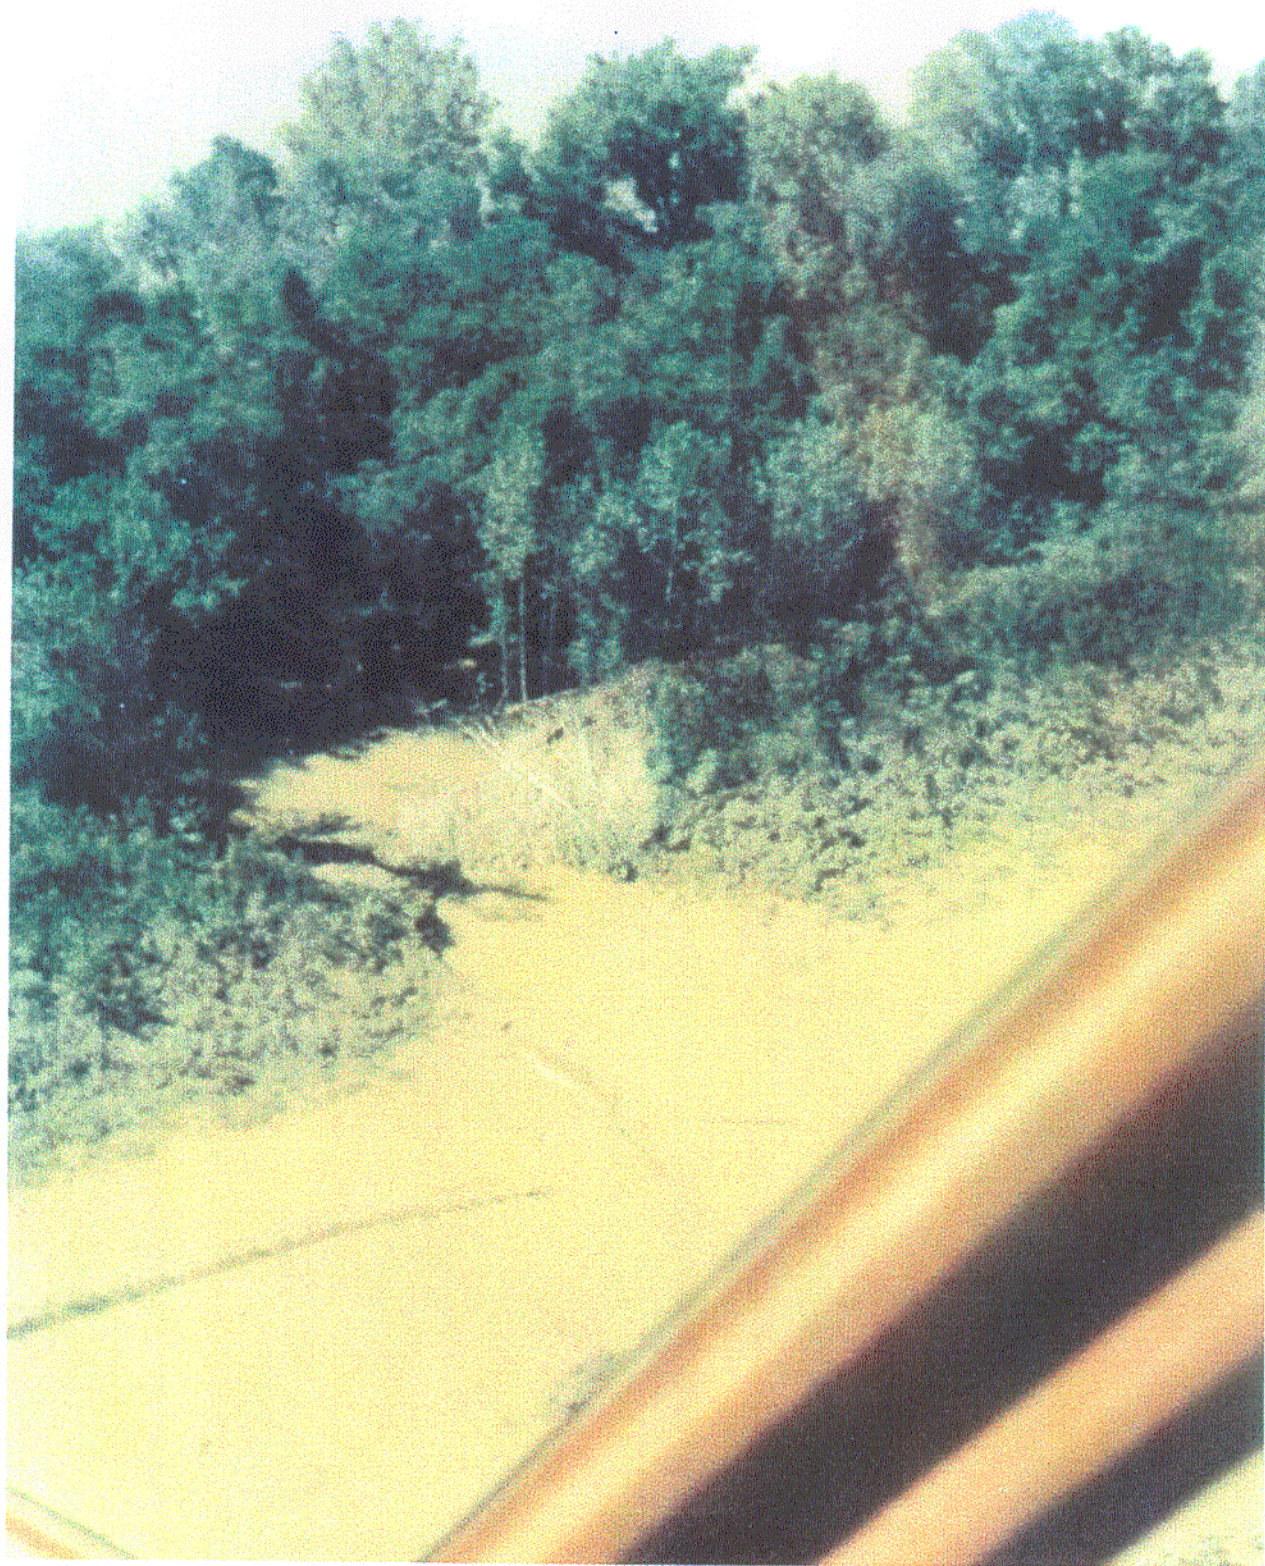
1976 Breach Ring 1 (South) looking W

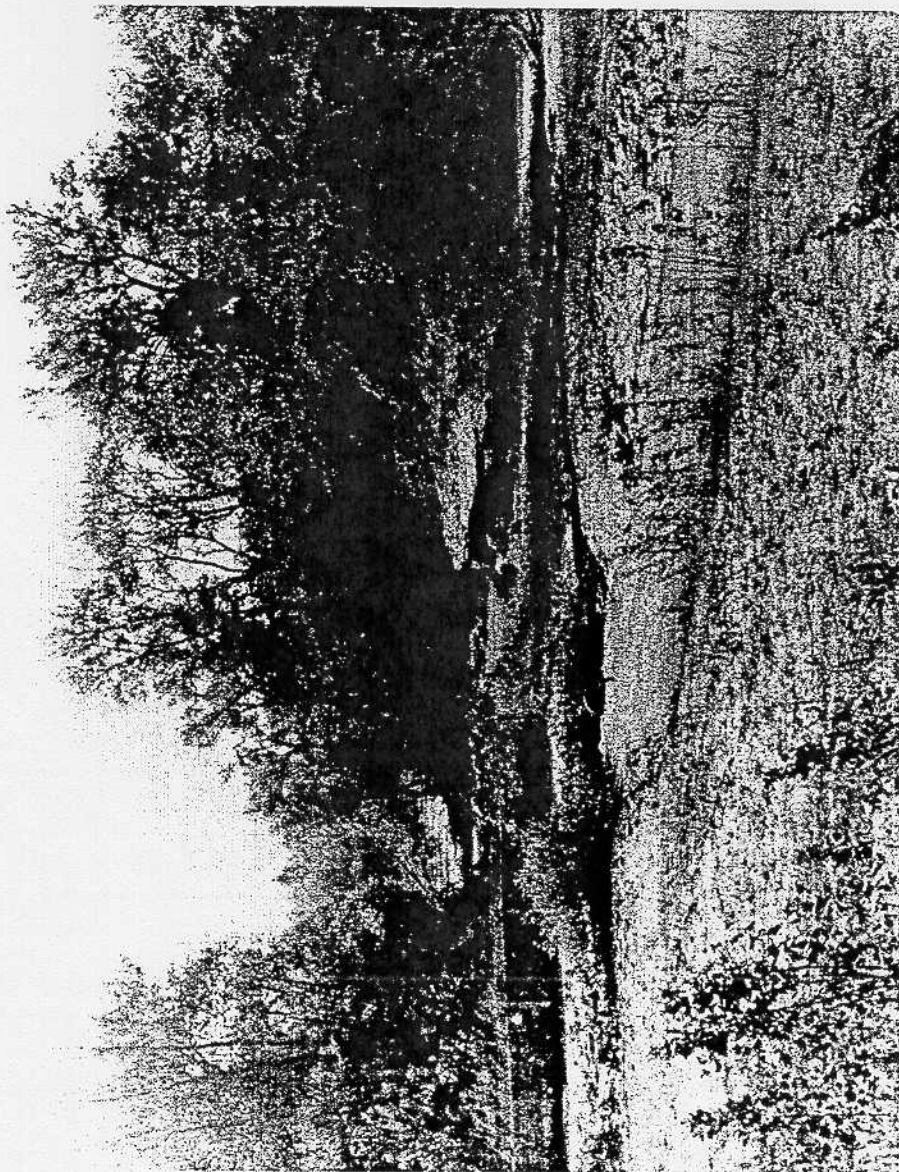
1976 Ring 1 Breach (North) looking West to Congaree

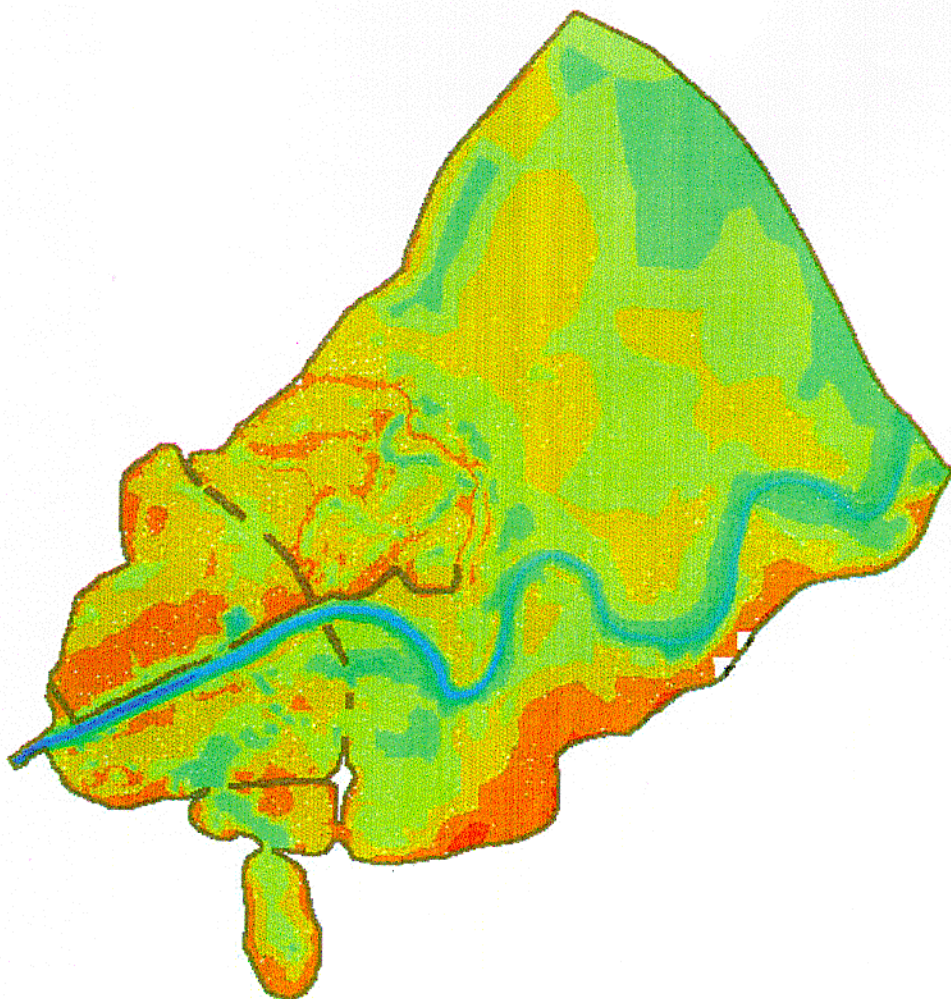
April 27, 2001 RMA-2 Output
Depth of Water

As discussed above, it is completely inappropriate to ignore all flows, regardless of depth, that do not meet CV's artificial 1FPS/PTC/CF definition. When the 1FPS/PTC/CF limitation is taken off, CV's own model output shows that significant flow, with significant volumes, will occur behind the levees and throughout the Richland County side of the Congaree River. An overlay of CV's "100-Year Flow" output onto FEMA's September 26, 2000 map shows that FEMA's equal conveyance method actually did a very good job at estimating the area of flow behind the levees. This overlay is shown as Attachment 5. Attachment 6 shows CV's map with a .5 fps cutoff (rather than 1 fps), showing that the majority of the Richland County area is covered with moving water. Attachment 7 shows water depths on the land. The end result is that CV's own modeling work concedes that a tremendous amount of moving water will come behind the levees, thereby conveying waters from the 100-Year flood that, if displaced, would cause area BFEs to increase.
